Defensible-Space Readiness Report

Sample Parcel 12 · Example Hills HOA · Los Angeles County, California (fictional)

Report
TAI-DSP-SAMPLE-01

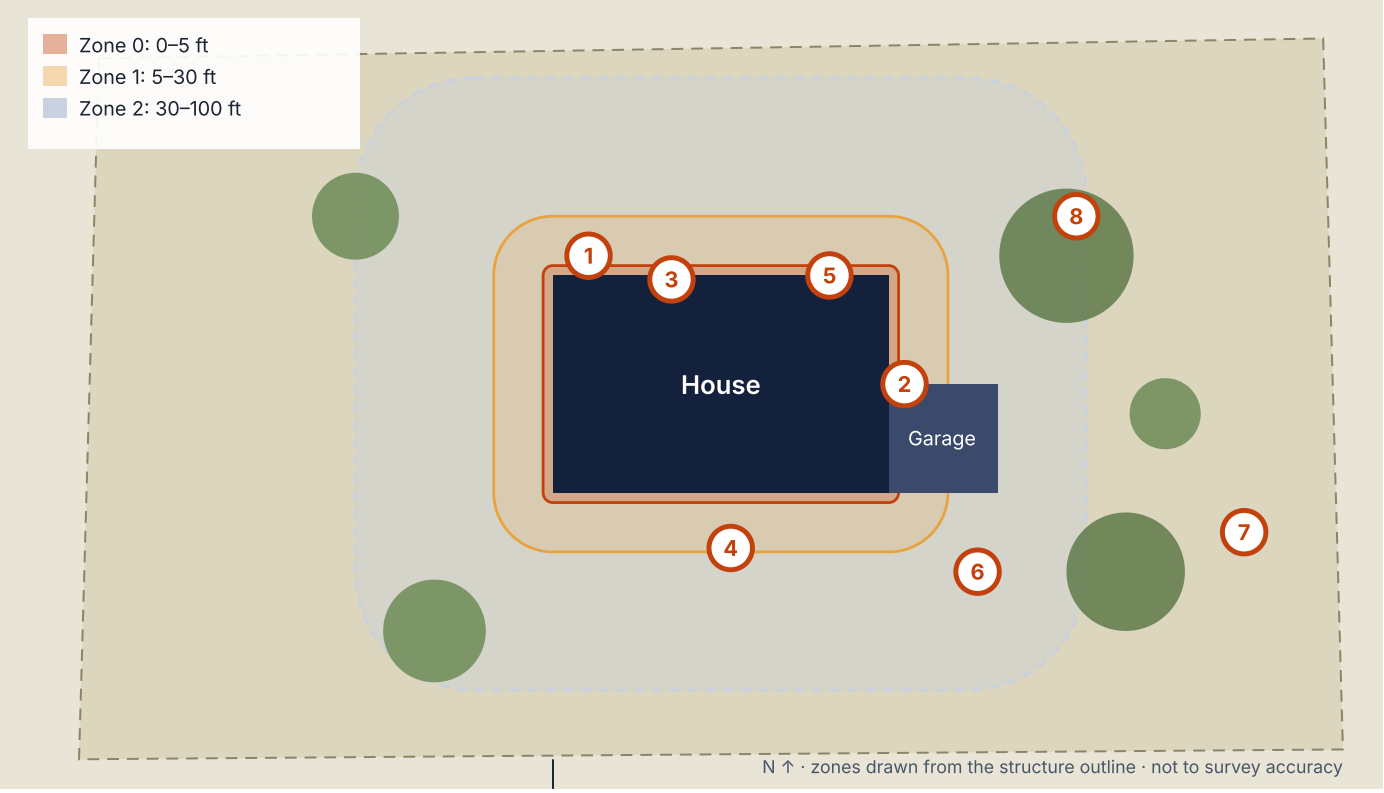
Eight fixes, three of them within 5 feet of the house

Numbers on the map match the fix list in Section 3. The most important work is in Zone 0, the first 5 feet around the house, where embers most often start fires.

Zone	Item	Status	Map	What we saw
Zone 0 (0–5 ft)	No bark mulch or other combustible ground cover	Fix	1	Bark mulch along the north wall
Zone 0 (0–5 ft)	No combustible fence or gate attached to the house	Fix	2	Wood side-yard fence meets the east wall
Zone 0 (0–5 ft)	Roof and gutters clear of leaves and needles	Fix	3	Debris in north and west gutters
Zone 0 (0–5 ft)	No combustible items stored under decks or eaves	Meets		Deck underside clear
Zone 0 (0–5 ft)	Vents screened with 1/8-inch metal mesh	Check on ground		Not visible from the air
Zone 0 (0–5 ft)	No dead plants or dry vegetation	Meets		
Zone 1 (5–30 ft)	Highly flammable shrubs removed or well spaced	Fix	4	Juniper hedge 12 ft from the south wall
Zone 1 (5–30 ft)	Tree branches at least 10 ft from the chimney	Fix	5	Pine limb about 6 ft from the chimney
Zone 1 (5–30 ft)	Firewood stored at least 30 ft from structures	Fix	6	Firewood stack about 18 ft from the garage

Zone 1 (5–30 ft)	Dead plants, grass and weeds removed	Meets		
Zone 1 (5–30 ft)	Space between trees and shrub groups	Meets		
Zone 1 (5–30 ft)	Propane tank clear of vegetation for 10 ft	Meets		Tank on the west side, clear
Zone 2 (30–100 ft)	Annual grass cut to 4 inches or less	Fix	7	Dry grass about 8–12 in on the east slope
Zone 2 (30–100 ft)	Ladder fuels removed under trees	Fix	8	Brush under two oaks reaches the lower limbs
Zone 2 (30–100 ft)	Horizontal spacing between shrubs and trees	Meets		
Zone 2 (30–100 ft)	Fallen leaves and needles under 3 inches deep	Meets		
Zone 2 (30–100 ft)	Exposed wood piles removed or covered	Meets		
Access	Address visible from the street; driveway clear 10 ft wide	Meets

Map	Zone	Fix	When	Cost
1	Zone 0	Replace bark mulch along the north wall with gravel, pavers or bare soil for the first 5 ft.	This weekend	$
2	Zone 0	Replace the last 5 ft of wood fence at the east wall with metal, or add a metal gate section.	Before inspection	$$
3	Zone 0	Clean north and west gutters; consider metal gutter guards.	This weekend	$
4	Zone 1	Remove the juniper hedge near the south wall or thin it into widely spaced groups.	Before inspection	$$
5	Zone 1	Trim the pine limb back to at least 10 ft from the chimney.	Before inspection	$$
6	Zone 1	Move the firewood stack at least 30 ft from the garage, or cover it.	This weekend	$
7	Zone 2	Mow the east slope grass to 4 inches or less and keep it there through fire season.	By May 1	$
8	Zone 2	Clear brush under the two oaks and limb trees up 6 ft from the ground.	By May 1	$$
