HOA DEFENSIBLE-SPACE SEASON PASS · COMMUNITY READINESS REPORT

Example Hills HOA · 42 homes plus common areas · Los Angeles County, California (fictional)

Spring flight
March 9, 2027 (sample)

Report
TAI-HOA-SAMPLE-01

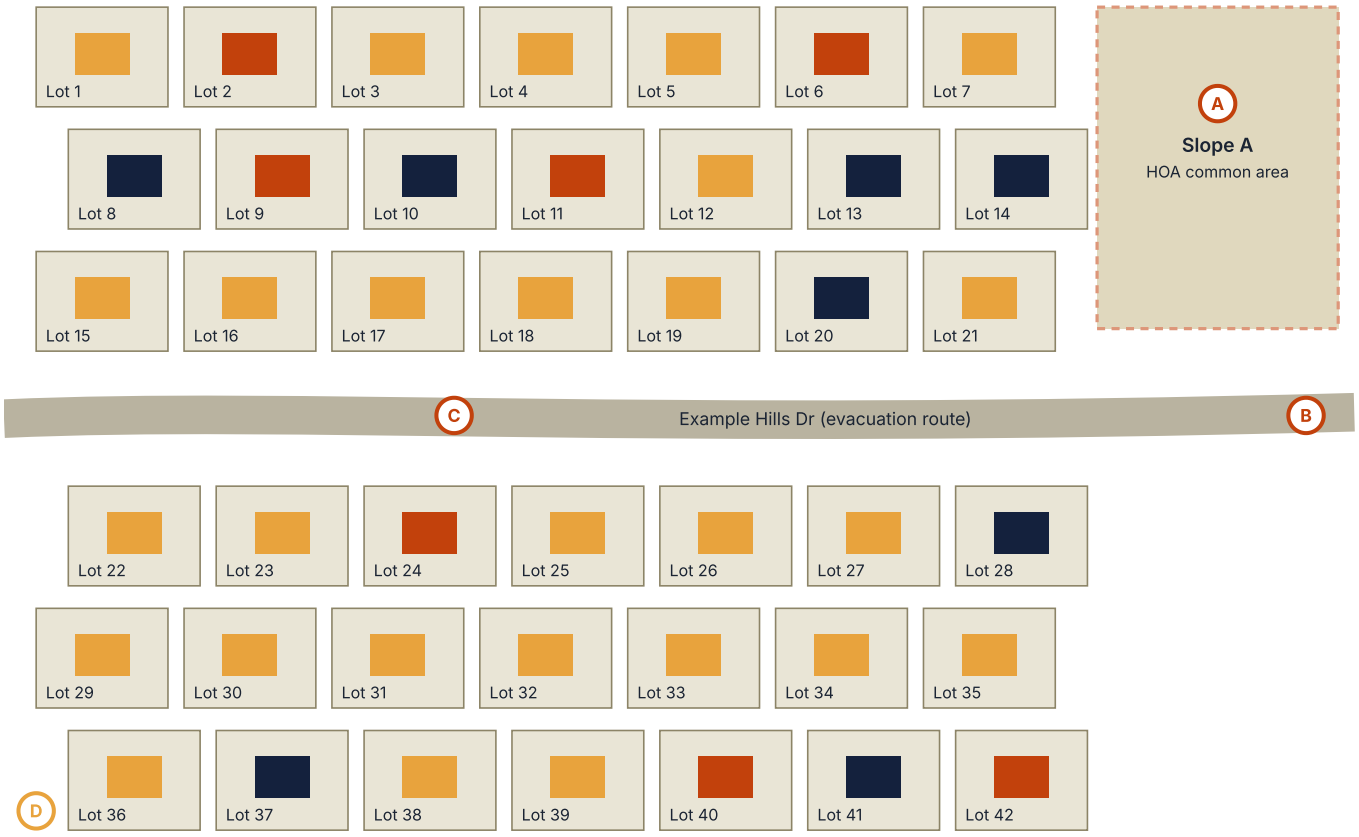
8 of 42 homes are ready now; most fixes are cheap and in the first 5 feet

8 of 42
homes ready for inspection today

19
homes with at least one Zone 0 fix (the first 5 ft)

56
fixes across all homes, each on that home's parcel report

4
common-area items for the HOA to schedule

Ready (8) Minor fixes (27) Needs work (7) · Letters mark common-area items (Section 3).

Every home received its own parcel report with a numbered fix list. LA County Fire inspections begin around June 1, so the recheck flight on May 11 gives owners time to finish and the board a completion record.

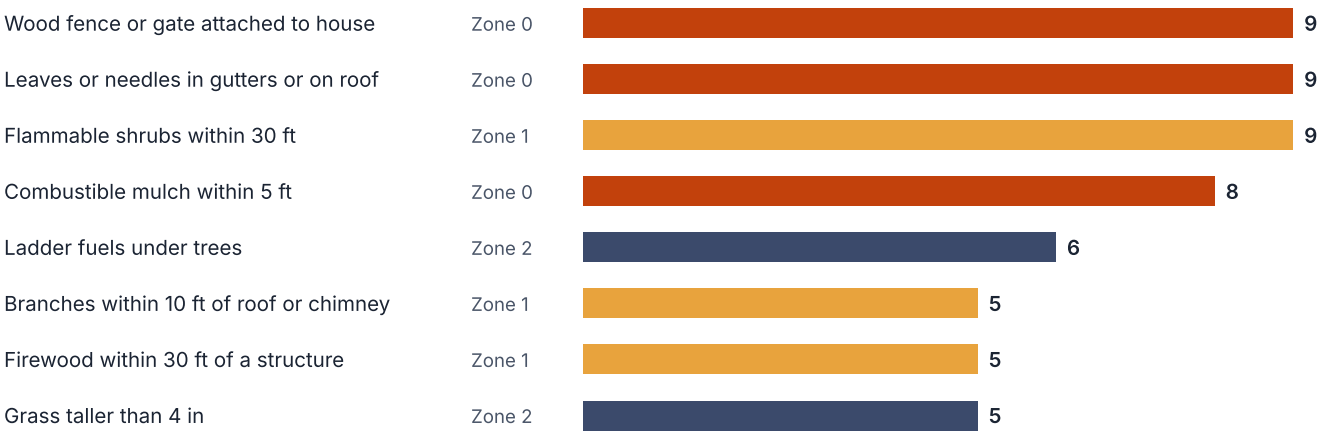
The same few fixes come up again and again

Number of homes with each item. Zone 0 items (red) matter most: embers that land within 5 feet of a house start most home ignitions.

- **Mulch swap day:** 8 homes have combustible mulch near the house. One bulk gravel order and a shared work day costs far less than each owner hiring separately.
- **Fence-end retrofits:** one contractor quote for metal gate sections at the house end of wood fences, at a group rate.
- **Chipper day:** book a chipper for trimmed branches, juniper and ladder fuels; many fire safe councils run free or low-cost chipper programs.
- **Gutter cleaning:** a single vendor for all homes before May 1.
